**Flood Control Project Maintenance  
Levee Inspections**  
**LMA District Cover Sheet**  
**Spring 2019 Levee Inspection Results**

**Reclamation District No. 2103 Wheatland Vicinity**

**Spring 2019 Levee Inspection Results**

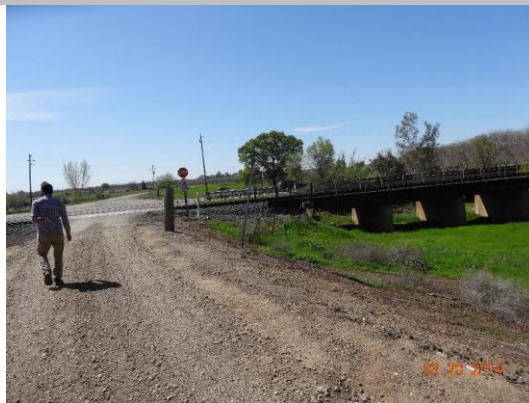
Photo 2 of 3 : UCIP\_SP\_2019\_39987\_71884.jpg

View of levee crown and waterward side.

LM Start	0.56	Rating **	M	Issue No.	32 (cont)	
LM End	0.56	Issue Type +	En	Location *		
Category	Supplemental			GPS Latitude/Longitude		
				Start	End	
Item	DWR UCIP Field Study			39.022665 °	39.022665 °	
				-121.444688 °	-121.444688 °	
DWR ID	24879					
Comment Code						
Inspector Comment						
FS_ID:39987 DS_ID:24879 EP_NO: N/A Repair Type: Non-Urgent Crossing Status: Indicator Found UCIP Comments: 03/04/2014 Need to contact owner to obtain depth of line through levee. Also need permit authorizing conduit through levee. (O. Magana - DWR UCIP) FIELD_STRUCT_DESC: Conduit line through levee. Markers visible on both sides. FS Date: 3/4/2014

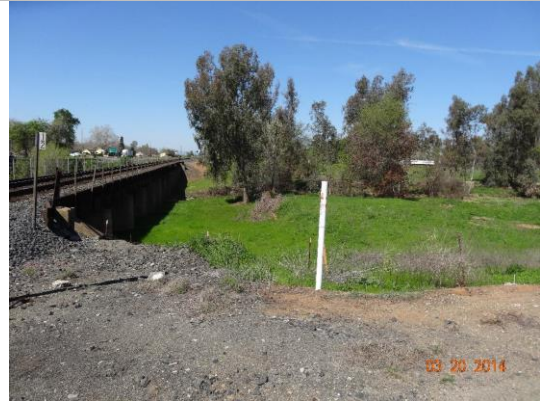
Photo 3 of 3 : UCIP\_SP\_2019\_39987\_71886.jpg

View of waterward side.

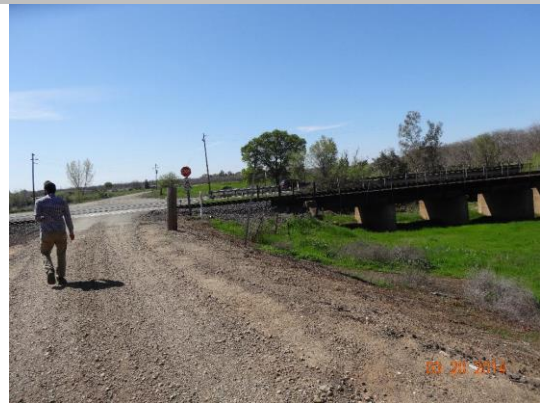
Photo 1 of 3 : UCIP\_SP\_2019\_38323\_69860.jpg

Comment Code						
Inspector Comment						
FS_ID:38323						
DS_ID:19469						
EP_NO: 2098						
Repair Type: Non-Urgent						
Crossing Status: Indicator Found						
UCIP Comments: 03/20/2014 Need to contact owner to determine status of crossing. Need date of last inspection and confirmation that crossing is still in operable condition. (O. Magana - DWR UCIP)						
FIELD_STRUCT_DESC: 16-inch steel gas line through the levee, 3 feet below the crown. Marker on waterside (WS) slope. (16-inch line authorized under Permit No. 2098, 1955-Pacific Gas and Electric Company [PG&E]). [Additional Reference(s): DWR Levee Logs, 2005. USACE Sacramento O&M Manual Unit No. 146, November 1962, (HLM 0.56)]						
FS Date: 3/20/2014

View of levee crown at crossing.

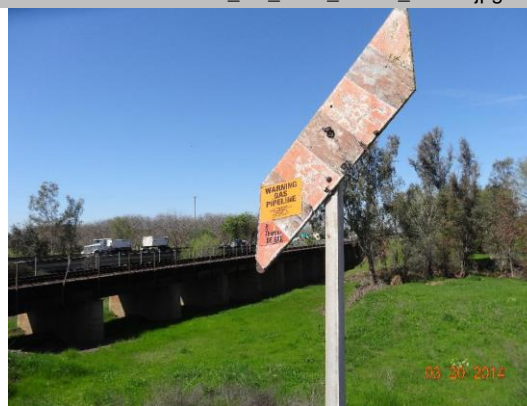
Photo 2 of 3 : UCIP\_SP\_2019\_38323\_69859.jpg

Comment Code						
Inspector Comment						
FS_ID:38323 DS_ID:19469 EP_NO: 2098 Repair Type: Non-Urgent Crossing Status: Indicator Found UCIP Comments: 03/20/2014 Need to contact owner to determine status of crossing. Need date of last inspection and confirmation that crossing is still in operable condition. (O. Magana - DWR UCIP) FIELD_STRUCT_DESC: 16-inch steel gas line through the levee, 3 feet below the crown. Marker on waterside (WS) slope. (16-inch line authorized under Permit No. 2098, 1955-Pacific Gas and Electric Company [PG&E]). [Additional Reference(s): DWR Levee Logs, 2005. USACE Sacramento O&M Manual Unit No. 146, November 1962, (HLM 0.56)] FS Date: 3/20/2014

Marker visible waterward side.

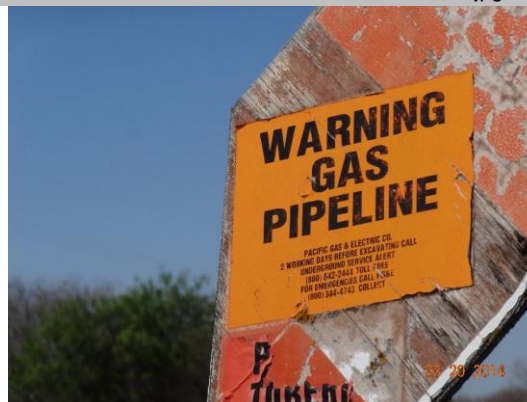
Photo 3 of 3 : UCIP\_SP\_2019\_38323\_69858.jpg

Contact information of owner.

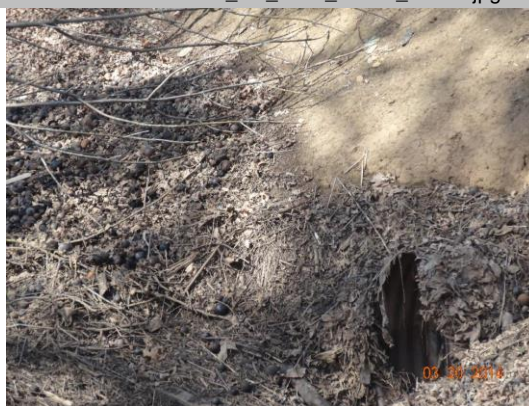
Photo 2 of 3 : UCIP\_SP\_2019\_38325\_69868.jpg

LM Start	0.82	Rating **	A/W	Issue No.	36 (cont)	
LM End	0.82	Issue Type +	Ma	Location *		
Category	Supplemental			GPS Latitude/Longitude		
				Start		End
Item	DWR UCIP LMA Responsibility			39.024811 °		39.024811 °
				-121.440750 °		-121.440750 °
DWR ID	19471					
Comment Code						
Inspector Comment						
FS_ID:38325 DS_ID:19471 EP_NO: N/A Repair Type: No Action Needed Crossing Status: Found UCIP Comments: FIELD_STRUCT_DESC: 36-inch corrugated metal drainage pipe through the levee, 14.4 feet below the crown. Concrete headwall, flap-gate, and 3-foot by 6-foot concrete splash apron located on the waterside (WS) toe. Outfall drain from old Grasshopper Slough. [Additional Reference(s): DWR Levee Logs, 2005. USACE Sacramento O&M Manual Unit No. 146, November 1962, (HLM 0.83)] FS Date: 3/20/2014

Close up view of crossing from landward side.

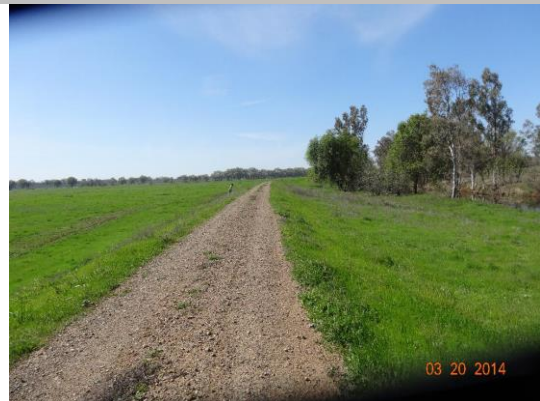
Photo 1 of 3 : UCIP\_SP\_2019\_41183\_69917.jpg

Comment Code						
Inspector Comment						
FS_ID:41183 DS_ID:19473 EP_NO: 1886 Repair Type: Non-Urgent Crossing Status: Indicator Found UCIP Comments: 03/20/2014 Need to coordinate with owner. Severely corroded section of steel pipe present on waterward side--no other evidense present at this location. Owner will need to coordinate with CVFPB and DWR-Inspector to determine proper action to abandon crossing. (O. Magana - DWR UCIP) FIELD_STRUCT_DESC: *ABANDONED* 12-inch steel irrigation pipe through the levee, 3.1 feet below the crown. Siphon breaker on the waterward slope. Concrete standpipe at the landward toe. Vertical pump on waterside (WS). Open on WS end. Permit includes gravel dam through channel of Dry Creek. Crossing is angled 45 degrees. (10-inch pipe authorized under Permit No. 1886, 1959-R. H. Blackford, Jr.) [Additional Reference(s): DWR Levee Logs, 2005. USACE Sacramento O&M Manual Unit No. 146, November 1962, (HLM 1.86)] FS Date: 3/20/2014

Overview of levee crown.

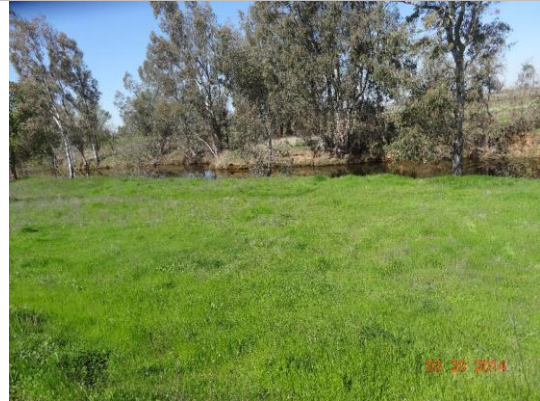
Photo 2 of 3 : UCIP\_SP\_2019\_41183\_69916.jpg

Comment Code						
Inspector Comment						
FS_ID:41183 DS_ID:19473 EP_NO: 1886 Repair Type: Non-Urgent Crossing Status: Indicator Found UCIP Comments: 03/20/2014 Need to coordinate with owner. Severely corroded section of steel pipe present on waterward side--no other evidense present at this location. Owner will need to coordinate with CVFPB and DWR-Inspector to determine proper action to abandon crossing. (O. Magana - DWR UCIP) FIELD_STRUCT_DESC: *ABANDONED* 12-inch steel irrigation pipe through the levee, 3.1 feet below the crown. Siphon breaker on the waterward slope. Concrete standpipe at the landward toe. Vertical pump on waterside (WS). Open on WS end. Permit includes gravel dam through channel of Dry Creek. Crossing is angled 45 degrees. (10-inch pipe authorized under Permit No. 1886, 1959-R. H. Blackford, Jr.) [Additional Reference(s): DWR Levee Logs, 2005. USACE Sacramento O&M Manual Unit No. 146, November 1962, (HLM 1.86)] FS Date: 3/20/2014

View of waterward side.

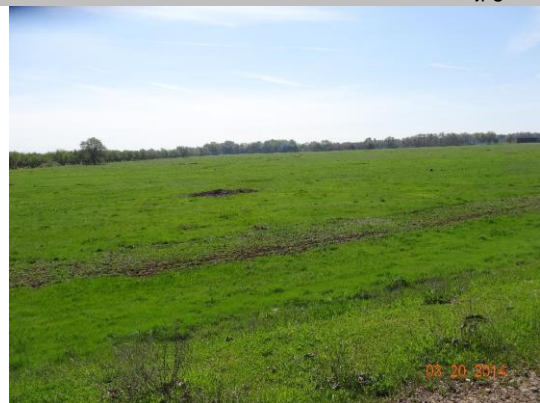
Photo 3 of 3 : UCIP\_SP\_2019\_41183\_69915.jpg

View of landward side.

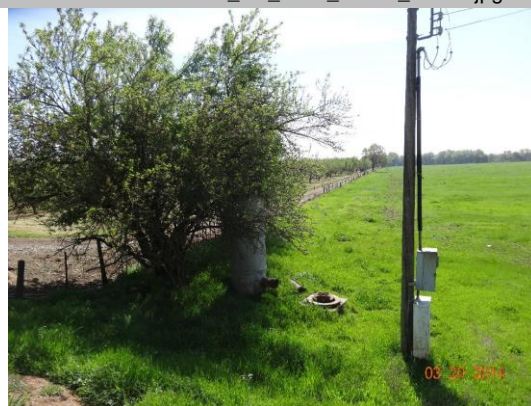
Photo 1 of 3 : UCIP\_SP\_2019\_38327\_69881.jpg

LM Start	1.86	Rating **	M	Issue No.	38
LM End	1.86	Issue Type +	En	Location *	
Category	Supplemental			GPS Latitude/Longitude	
				Start	End
Item	DWR UCIP Field Study			39.029694 °	39.029694 °
				-121.423946 °	-121.423946 °
DWR ID	19512				
Comment Code					
Inspector Comment					
FS_ID:38327					
DS_ID:19512					
EP_NO: N/A					
Repair Type: Non-Urgent					
Crossing Status: Indicator Found					
UCIP Comments: 03/20/2014 Unable to determine if there is a crossing through pipe. Will need to coordinate with owner to determine additional information about appurtenances found on landward side. (O. Magana - DWR UCIP)					
FIELD_STRUCT_DESC: Irrigation pump, service pole, and 36-inch concrete standpipe, 5 feet from the landside (LS) toe. No pump was found during field visit 3/20/14. [Additional Reference(s): DWR Levee Logs, 2005]					
FS Date: 3/20/2014

View of landward side.

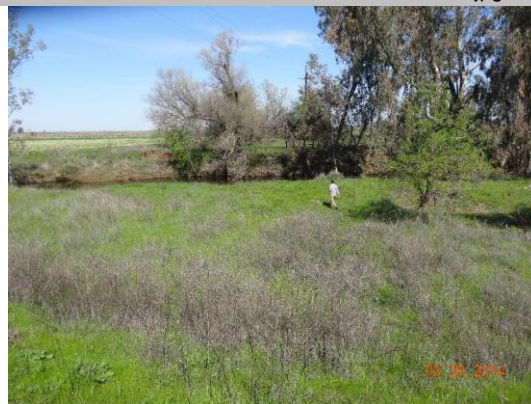
Photo 2 of 3 : UCIP\_SP\_2019\_38327\_69880.jpg

View of waterward side.

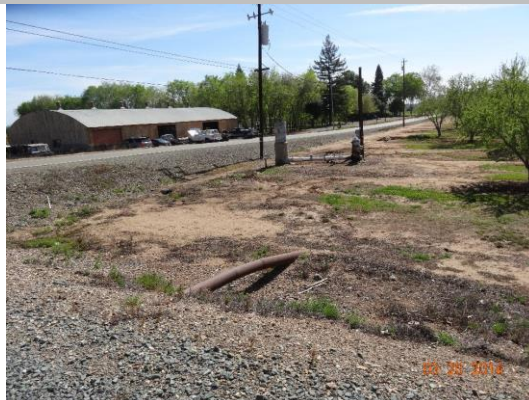
Photo 3 of 3 : UCIP\_SP\_2019\_38331\_69892.jpg

Comment Code						
Inspector Comment						
FS_ID:38331						
DS_ID:19477						
EP_NO: N/A						
Repair Type: Non-Urgent						
Crossing Status: Found						
UCIP Comments: 03/20/2014 Need to contact owner to determine status. (O. Magana - DWR UCIP)						
FIELD_STRUCT_DESC: 8-inch steel irrigation pipe through the levee, 3.1 feet below the crown. Siphon breaker on the waterward slope. Pump on the landward side. Pipe crosses creek to orchard on north side. (two 12-inch pipes authorized under Permit No. 1887, 1954-H. B. Waltz, HLM 2.41 and 2.68) [Additional Reference(s): DWR Levee Logs, 2005. USACE Sacramento O&M Manual Unit No. 146, November 1962, (HLM 2.68), 8-inch]						
FS Date: 3/20/2014

View of landward side.

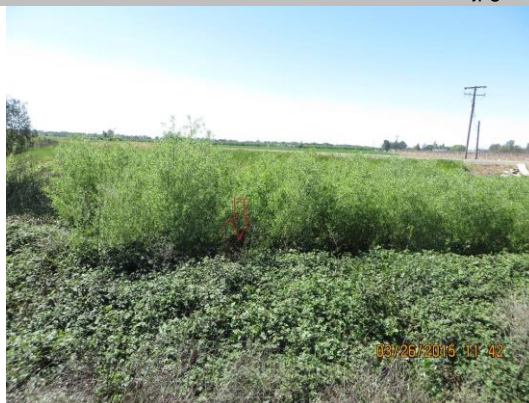
Photo 2 of 3 : UCIP\_SP\_2019\_53435\_73428.jpg

FS\_ID:53435  
DS\_ID:19478  
EP\_NO: N/A  
Repair Type: Non-Urgent  
Crossing Status: Found  
UCIP Comments: 10/30/2018 Levee slopes have been cleared of dense vegetation. LS inlet has been modified and improved. Corrosion and minor sediment observed inside the pipe. Flap gate on the WS is operable. This crossing is part of DWR's Deferred Maintenance Project (DMP). Crossing has been downgraded from Urgent to Non-Urgent because no integrity issues were observed on the slopes or the pipe. Recommend clearing the sediment from the pipe and complete an internal inspection to determine the integrity of pipe through the levee. Correction to 2016 inspection entry, levee height is about 10-12 feet high instead of the 3-4 feet high previously reported. (O. Magana - DWR UCIP)7/08/2016 Meet with Tom Engler from MBK Engineers, District Engineer, and the District is in the process of trying to deauthorize portion of Unit 1. This section of the levee protects an orchard--levee is approximately 3-4 feet tall. (DWR UCIP - omagana)3/26/2015 Flapgate open and won't close due to vegetation and soil blocking its operation. (DWR UCIP - omagana)

Flapgate at WS berm blocked by soil and vegetation buildup.

Location of pipe and flapgate on WS berm.

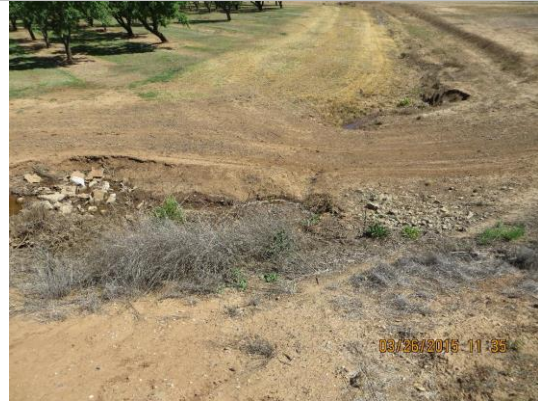
Photo 3 of 3 : UCIP\_SP\_2019\_53435\_73427.jpg

Comment Code						
Inspector Comment						
FS_ID:53435 DS_ID:19478 EP_NO: N/A Repair Type: Non-Urgent Crossing Status: Found UCIP Comments: 10/30/2018 Levee slopes have been cleared of dense vegetation. LS inlet has been modified and improved. Corrosion and minor sediment observed inside the pipe. Flap gate on the WS is operable. This crossing is part of DWR's Deferred Maintenance Project (DMP). Crossing has been downgraded from Urgent to Non-Urgent because no integrity issues were observed on the slopes or the pipe. Recommend clearing the sediment from the pipe and complete an internal inspection to determine the integrity of pipe through the levee. Correction to 2016 inspection entry, levee heigh is about 10-12 feet high instead of the 3-4 feet high previously reported. (O. Magana - DWR UCIP)7/08/2016 Meet with Tom Engler from MBK Engineers, District Engineer, and the District is in the process of trying to deauthorize portion of Unit 1. This section of the levee protects an orchard--levee is approximately 3-4 feet tall. (DWR UCIP - omagana)3/26/2015 Flapgate open and won't close due to vegetation and soil blocking its operation. (DWR UCIP - omagana) FIELD_STRUCT_DESC: 24-inch corrugated metal drainage pipe through the levee, 12 feet below the crown. Flap gate is located on the waterside (WS) end. [Additional Reference(s): DWR Levee Log, 2005]. FS Date: 10/30/2018 1:54:00 PM

Pipe visible at LS toe.

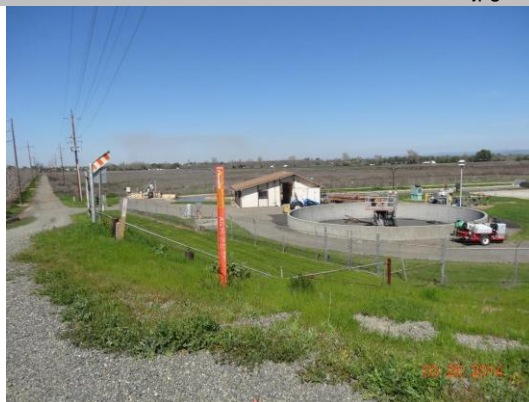
Photo 2 of 2 : UCIP\_SP\_2019\_39992\_69913.jpg

Marker visible on landward side.

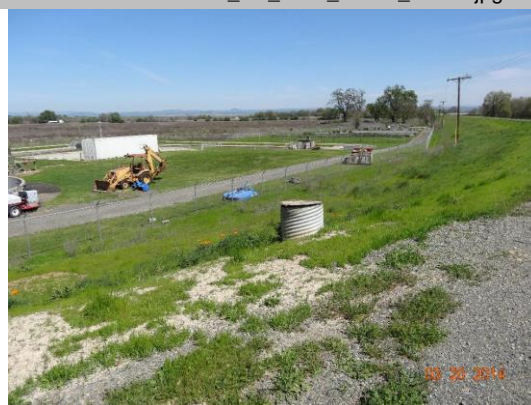
Photo 2 of 2 : UCIP\_SP\_2019\_39993\_69911.jpg

CMP riser located on landward side.

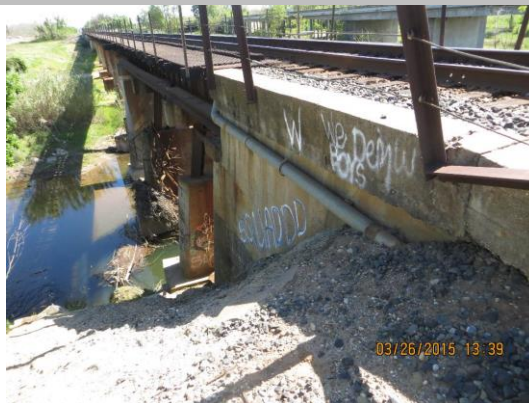
Photo 3 of 3 : UCIP\_SP\_2019\_44089\_73566.jpg

LM Start	1.76	Rating **	M	Issue No.	28 (cont)	
LM End	1.76	Issue Type +	En	Location *		
Category	Supplemental			GPS Latitude/Longitude		
				Start	End	
Item	DWR UCIP Field Study			39.000557 °	39.000557 °	
				-121.406581 °	-121.406581 °	
DWR ID	25090					
Comment Code						
Inspector Comment						
FS_ID:44089						
DS_ID:25090						
EP_NO: N/A						
Repair Type: Non-Urgent						
Crossing Status: Found						
UCIP Comments: 03/26/2015 No permit identified for this crossing. (W. Wylie - DWR UCIP)						
FIELD_STRUCT_DESC: Fiber optic line of unknown material through the levee at unknown depth. Marker visible on waterside (WS) shoulder. 6-inch steel pipe visible on upstream side of railroad trestle.						
FS Date: 3/26/2015

6-inch steel conduit visible on upstream side of railroad bridge.

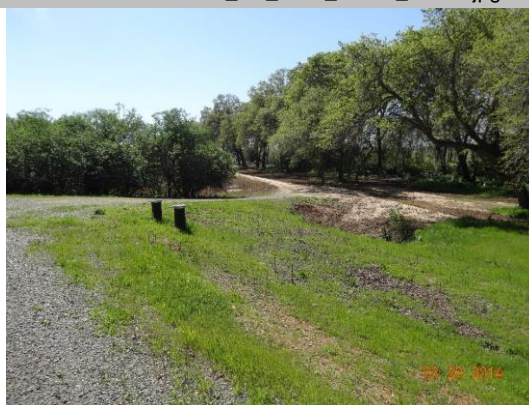
Photo 1 of 3 : UCIP\_SP\_2019\_40045\_71908.jpg

Comment Code					
Inspector Comment					
FS_ID:40045 DS_ID:19488 EP_NO: N/A Repair Type: Non-Urgent Crossing Status: Found UCIP Comments: 03/20/2014 Pipe has been plugged--visible on landward side. Need to contact owner to obtain additional information about abandoned crossing. (O. Magana - DWR UCIP) FIELD_STRUCT_DESC: 1 of 2: 30-inch corrugated metal irrigation pipe through levee, 13.8 feet below crown. Slide gates in 42-diameter riser on waterside (WS) slope. Concrete "U" headwall at both levee toes. Grouted spillway on landside (LS). [Additional Reference(s): DWR Levee Logs, 2005. USACE Sacramento O&M Manual Unit No. 146, November 1962, (HLM 2.67), two 30-inch] FS Date: 3/20/2014

View of waterward shoulder.

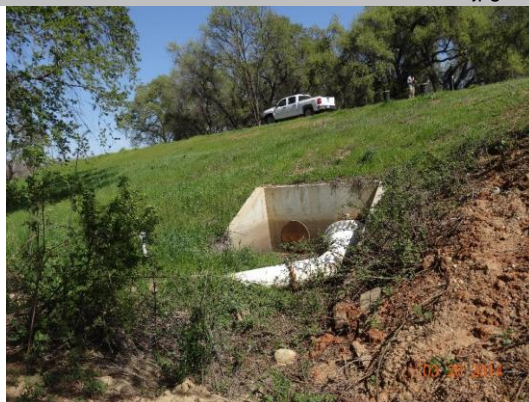
Photo 3 of 3 : UCIP\_SP\_2019\_40045\_71912.jpg

Comment Code						
Inspector Comment						
FS_ID:40045 DS_ID:19488 EP_NO: N/A Repair Type: Non-Urgent Crossing Status: Found UCIP Comments: 03/20/2014 Pipe has been plugged--visible on landward side. Need to contact owner to obtain additional information about abandoned crossing. (O. Magana - DWR UCIP) FIELD_STRUCT_DESC: 1 of 2: 30-inch corrugated metal irrigation pipe through levee, 13.8 feet below crown. Slide gates in 42-diameter riser on waterside (WS) slope. Concrete "U" headwall at both levee toes. Grouted spillway on landside (LS). [Additional Reference(s): DWR Levee Logs, 2005. USACE Sacramento O&M Manual Unit No. 146, November 1962, (HLM 2.67), two 30-inch] FS Date: 3/20/2014

View of waterward side.

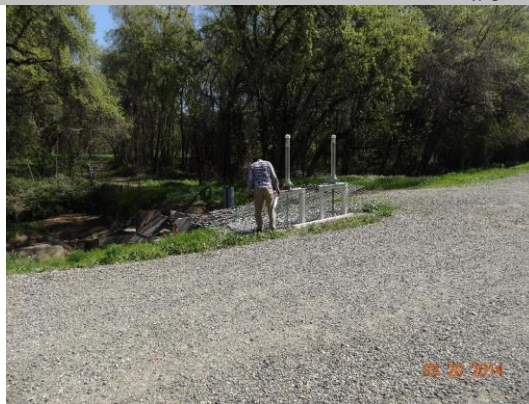
Photo 2 of 3 : UCIP\_SP\_2019\_40046\_71914.jpg

Comment Code					
Inspector Comment					
FS_ID:40046 DS_ID:19504 EP_NO: N/A Repair Type: Non-Urgent Crossing Status: Found UCIP Comments: 03/20/2014 Need to contact owner to determine status--crossing appears to be modified. Need to contact owner to obtain additional information about modified crossing. (O. Magana - DWR UCIP) FIELD_STRUCT_DESC: 2 of 2: 30-inch corrugated metal irrigation pipe through levee, 13.8 feet below crown. Slide gates in 42-diameter riser on waterside (WS) slope. Concrete "U" headwall at both levee toes. Grouted spillway on landside (LS). [Additional Reference(s): DWR Levee Logs, 2005. USACE Sacramento O&M Manual Unit No. 146, November 1962, (HLM 2.67), two 30-inch] FS Date: 3/20/2014

View of landward side.

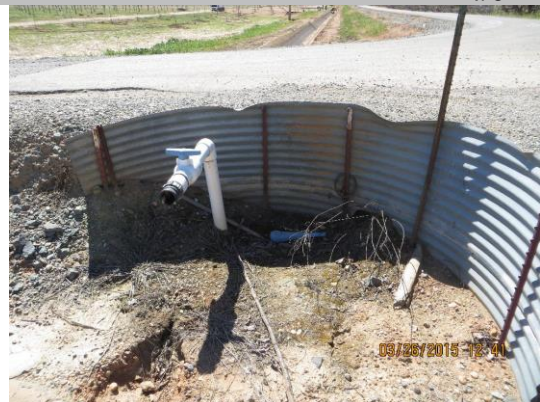
Photo 1 of 2 : UCIP\_SP\_2019\_43957\_73435.jpg

Comment Code					
Inspector Comment					
FS_ID:43957 DS_ID:19500 EP_NO: N/A Repair Type: Non-Urgent Crossing Status: Indicator Found UCIP Comments: 03/26/2015 Further evaluation necessary to determine alignment of crossing should be conducted. (W. Wylie - DWR UCIP) FIELD_STRUCT_DESC: 4-inch polyvinyl chloride (PVC) water line through levee, 6-feet below the levee crown. Ball valve and service connection point located on the landside (LS) shoulder. Pipe appears to run parallel to east, on LS slope just off crown but may cross at this location as well. [Additional Reference(s): USACE Sacramento O&M Manual Unit No. 146, November 1962, (HLM 4.05)] FS Date: 3/26/2015

Service connection and ball valve visible on LS shoulder.

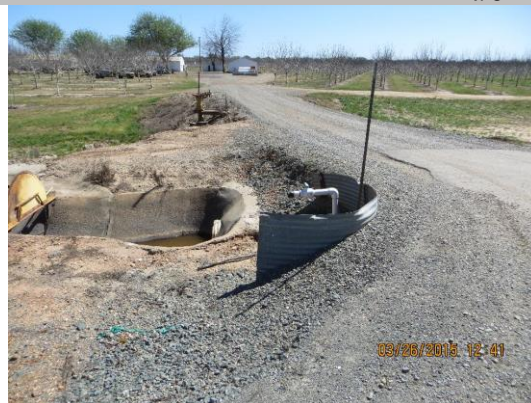
Photo 2 of 2 : UCIP\_SP\_2019\_43957\_73434.jpg

Comment Code						
Inspector Comment						
FS_ID:43957 DS_ID:19500 EP_NO: N/A Repair Type: Non-Urgent Crossing Status: Indicator Found UCIP Comments: 03/26/2015 Further evaluation necessary to determine alignment of crossing should be conducted. (W. Wylie - DWR UCIP) FIELD_STRUCT_DESC: 4-inch polyvinyl chloride (PVC) water line through levee, 6-feet below the levee crown. Ball valve and service connection point located on the landside (LS) shoulder. Pipe appears to run parallel to east, on LS slope just off crown but may cross at this location as well. [Additional Reference(s): USACE Sacramento O&M Manual Unit No. 146, November 1962, (HLM 4.05)] FS Date: 3/26/2015

Service connection and ball valve visible on LS shoulder.

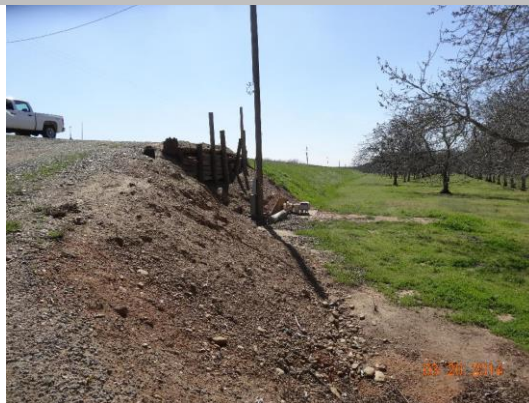
Photo 2 of 3 : UCIP\_SP\_2019\_40049\_71926.jpg

Comment Code					
Inspector Comment					
FS_ID:40049 DS_ID:19493 EP_NO: N/A Repair Type: Non-Urgent Crossing Status: Found UCIP Comments: 03/20/2014 Crossing has been modified---need to contact owner to obtain permit used for modification. (O. Magana - DWR UCIP) FIELD_STRUCT_DESC: 24-inch corrugated metal irrigation pipe through levee, 10.6 feet below the crown. Slide gate in concrete square riser (not 36-inch CM riser as mentioned in desk study) is located on the waterside (WS) slope. Concrete "U" headwall and trash rack on WS toe. 5-foot by 5-foot concrete distribution box and headwall located on the landside (LS) toe. [Additional Reference(s): DWR Levee Logs, 2005. USACE Sacramento O&M Manual Unit No. 146, November 1962, (HLM 4.87)] FS Date: 3/20/2014

Overview of waterward side.
